## Getting to grips with slips and trips

Real workplaces, real  
problems to be  
overcome, real solutions  
and real benefits.

Sharing experiences  
from real life

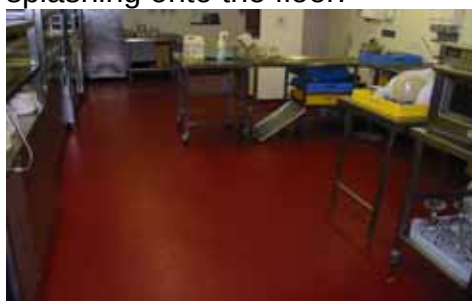
Tests by the Health & Safety Laboratory (HSL) using pendulum coefficient of friction and surface micro-roughness measurement techniques showed that the floor's slip resistance was 'borderline' when dry and unsatisfactory if wet. This was not felt to give enough grip for a kitchen where there was bound to be at least some splashing onto the floor.

resistance but eventually decided that the most effective option was to replace the floor covering. Management made sure that the new floor covering had been reliably tested for slip resistance and that it would be expected to perform well in a commercial kitchen situation.

The replacement floor (a 'safety' epoxy material with anti slip particles) was tested by HSL and the results indicated that it ought to perform well in both dry conditions and when subject to the sort of contamination that is to be expected in a busy kitchen.

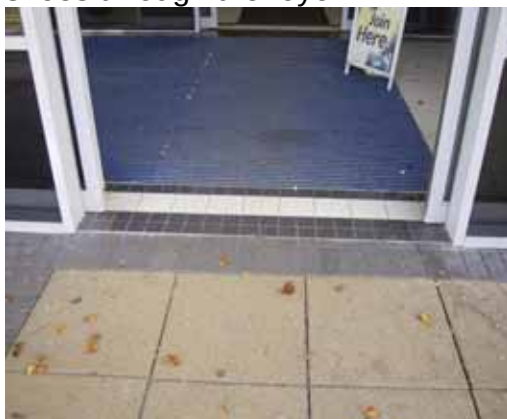
Investigations showed that these areas quickly became wet on rainy days with water being walked in on shoes through the foyer.

The entrance matting systems in place were not large enough to cope with the amount of water transferred onto the mats from pedestrian movement.

The supermarket also reviewed their store entrance matting system. The existing sunken matting was complimented by extra matting during wet conditions. In the longer term the supermarket built a canopy over the entrance to further reduce the direct ingress of water.

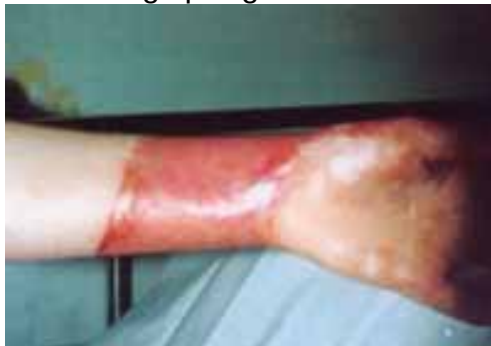
**Severe burn injury resulting from a simple slipping accident.**

The ice-making machine had been leaking for several days and

various attempts had been made by different contractors to cure the leak. No one had sole responsibility to co-ordinate the repair of faulty equipment and a lack of communication between different shift managers left the equipment leaking over a long period of time.

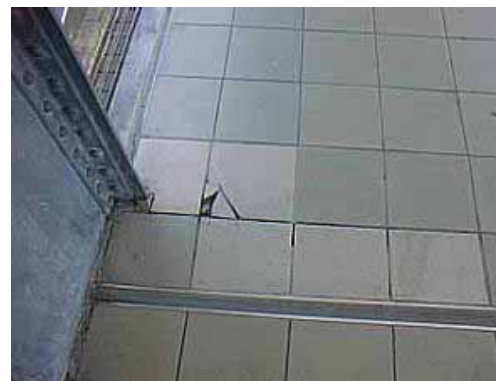
Initially, railway station management arranged for the ramps to be treated with an acid etch to try to increase the slip resistance of the tiles.

**Ramped walkway surface 'before'.**

This did help to reduce the number of slipping accidents. However, it was felt that more could be done. Later a second walkway surface was applied. This was an anti-slip reinforced plastic covering that was simply glued on top of the old ceramic tiled surface giving the visual effect of a brick pavior surface.

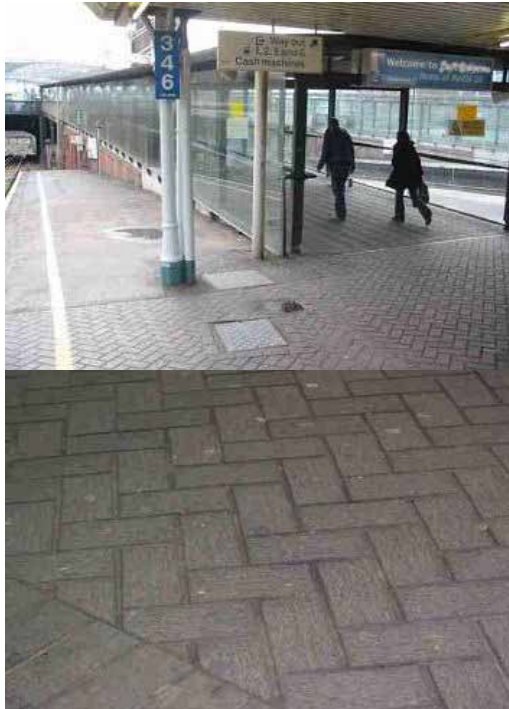
**Ramped walkways after resurfacing.**

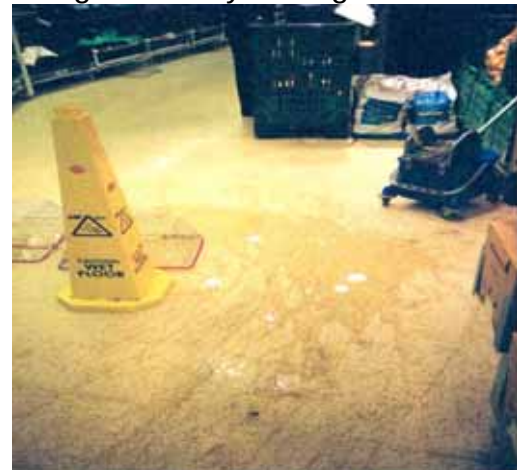
The EHO established that the chiller cabinet condensate drain had been leaking onto the floor all morning and into the afternoon. The manager was spoken to about taking action to keep the floor dry i.e. station a cleaner in the area at all times until the leak was repaired and using absorbent materials to soak up and contain the water. By the time the officer left the store the floor was dry and the situation was being effectively managed.

The company had a spillage procedure and this clearly set out the ways in which the manager should have managed the leak and the wet floor.

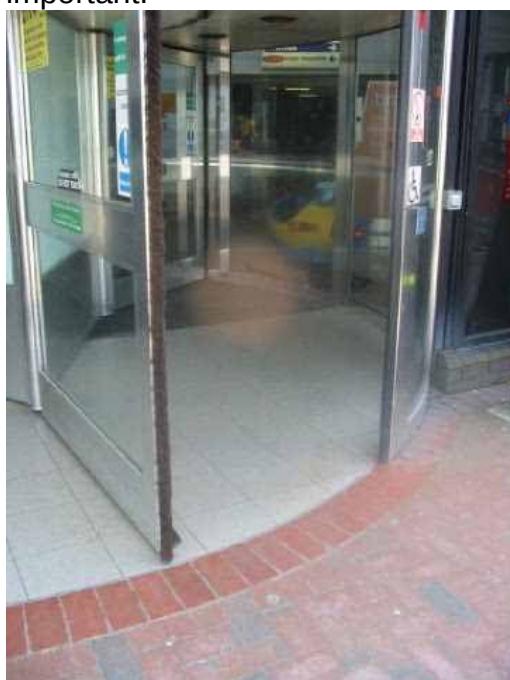
and old) are rushing, turning and distracted. Slip risk was identified as being high. The inner half of the floor within the circumference of the revolving door consists of coarse grit/dirt removal matting. Although this has some absorbent qualities its design (and heavily worn condition) render it of little use in preventing walk-in water being carried onto the adjacent concourse where control of contaminants is known to be important.

**Response.** Arrangements are being made to have the revolving door removed and pedestrian flow redirected to a better-controlled area. A decision made easier by the 'temperamental' nature of these particular powered doors.

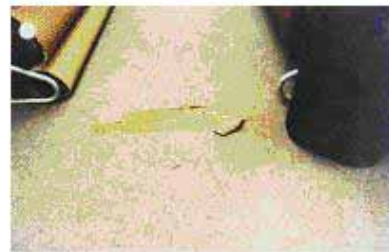
The shop floor was very congested with stock and goods were left in the main walkways. There were also areas of worn and damaged carpets in the public area. The warehouse at the rear of the premises was even more congested with stock, restricting access to the racking and obstructing the fire exit

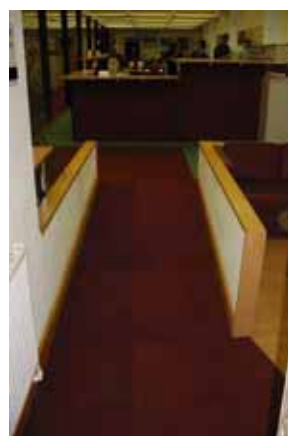
**'Sloped walkway which was not apparent at first glance.'**
