## Getting to grips with slips and trips

Real workplaces, real  
problems to be  
overcome, real solutions  
and real benefits.

Sharing experiences  
from real life

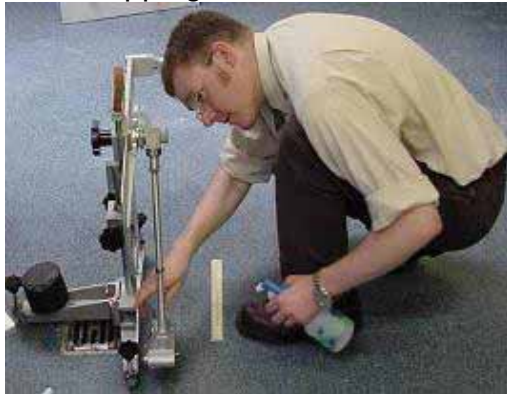
changing area as part of a refurbishment programme. The new floor was an epoxy resin incorporating anti-slip particles. However, as soon as the swimming pool re-opened following the refurbishment, over 30 slipping incidents were reported. The Health and Safety Laboratory (HSL) were called in to assess the floor and it was discovered that there were patches of resin floor with no anti-slip particles. Due to the lack of anti-slip particles, these areas were in fact just smooth resin and accident records showed that these areas were indeed responsible for the majority if not all of the slipping accidents.

**Assessing the floor surface.**

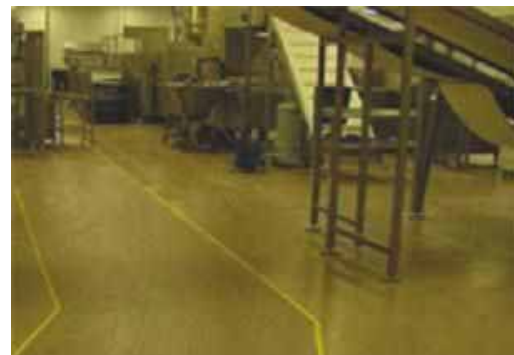
Assessments were carried out by HSL using standard pendulum and surface roughness analysis techniques. Results showed that contamination of the floor with clean water resulted in an

**Anti-slip factory walkway.**

appreciable slip risk. Work processes used within the factory made it very difficult to totally eliminate floor contamination. It was therefore decided that modification of the floor surface was the most practical solution to reduce risks of slipping.

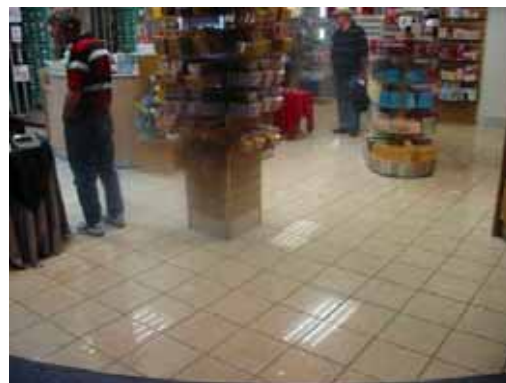
#### **'Duty Free' shop.**

High gloss ceramic decorative floor tiling with low microroughness. Originally thought to be likely to be a high-risk area but this proved not to be the case. The duty free shop is sited in the heart of the terminal building with no risk of walk-in water.

Floor cleaning takes place at night when the shop is closed to the public. A 'no food & drink' policy is enforced. There are no open products to contaminate the floor and bottle breakage responses and procedures are very well organised.

**Response.** Although the floor is glossy pedestrians never have anything other than a clean and dry floor to walk on. No action is needed.

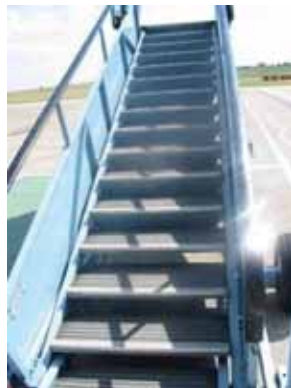
The movable steps are kept outside and are exposed to the weather and a variety of potential contaminants to the walking surface but the profiled rubber treads to the steps still offer reasonable slip resistance.

**Response.** Periodic cleaning of the treads to control contamination and monitoring of the condition of the rubber surface for hardening or perishing brought on by exposure to the elements.

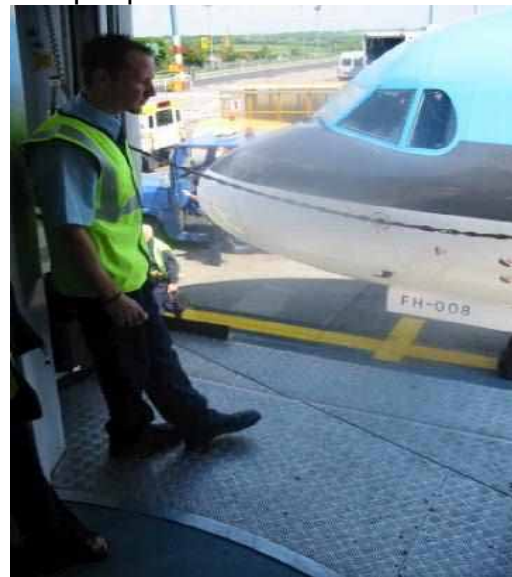
The air-bridges are floored with textured vinyl sheet for the most part and are cleaned to a high standard. Even with young and old, encumbered, rushing and distracted pedestrians the textured vinyl – protected as it is from foreseeable contamination of any significance – performs well. The last few feet of the air-bridges (where they dock with the aircraft and where the operative stands) are floored with metal chequerplate.

Experience and experimentation suggest that the slip resistance of metal chequerplate is not a direct function of the raised profiling pattern but related more closely to the microroughness of the upper surface (the foot contact surface) of each profile cleat. Microroughness measurements and analysis of the other relevant conditions indicate there is little problem if the chequerplate is kept clean and dry but that it offered poor slip

resistance if wet or contaminated. The most likely source of contamination is rainwater if the docking roller doors of the air-bridge are opened early in the docking process. This is of particular concern as, if the roller door is opened early, the operative is standing on a moving slippery surface close to an open drop to the tarmac below.

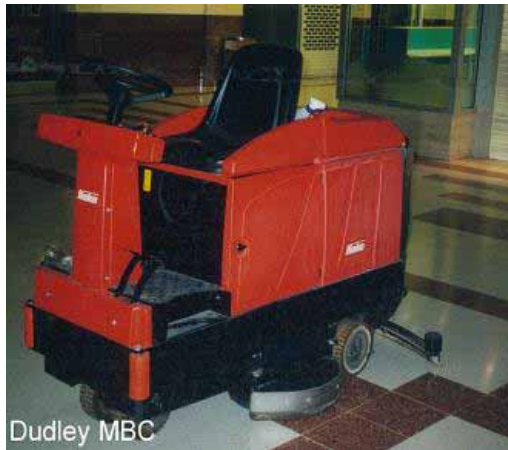
A contract floor cleaning company were using rider-operated scrubber-dryers to clean a large shopping mall after it had closed for the day. Unfortunately a pedestrian slipped over an unattended pool of water that had been left by the scrubber dryer. The pedestrian suffered head injuries and spent time recovering in hospital.

**Mechanical scrubber-dryer.**

On investigation it was found that when the scrubber-dryer turned around to begin another run down the mall, the operator raised the blade at the rear of the unit that deposited water and debris onto the floor.

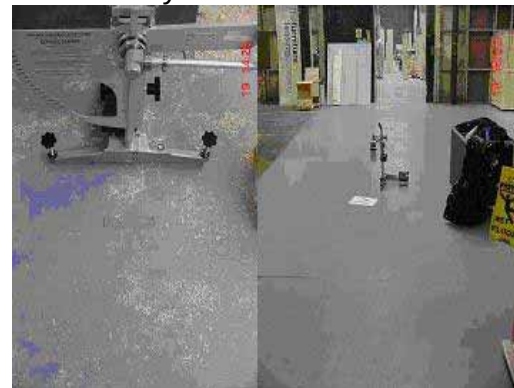
An employee in a pine factory slipped and cut himself on a poorly guarded machine whilst in the course of his work. As a result of this injury, HSE served a health and safety improvement notice on the company because the floor was found to be unacceptably slippery even in dry conditions.

**'Pendulum' tests on the factory floor.**

In addition, it was also found that furniture wax was being transferred directly onto the floor as products were being pushed around the factory and this may have contributed to the original accident.

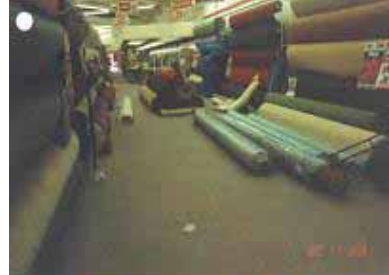
The shop floor was very congested with stock and goods were left in the main walkways. There were also areas of worn and damaged carpets in the public area. The warehouse at the rear of the premises was even more congested with stock, restricting access to the racking and obstructing the fire exit

Following the accident investigation, the company were prosecuted with contravening the Workplace (Health, Safety and Welfare) Regulations 1992 as the sales floor was obstructed with goods and also had badly worn areas of floor covering that were likely to cause a person to slip, trip or fall.

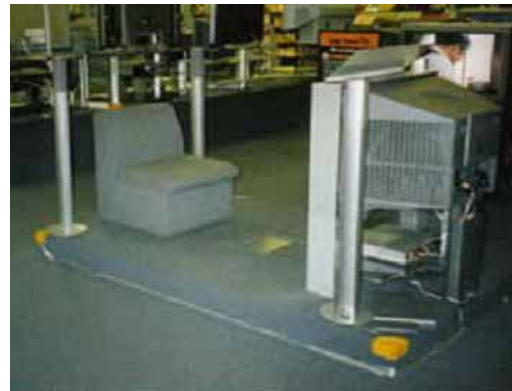
In Summer 2002 a member of the public tripped over one of 21 unmarked plinths and fractured their arm. The plinths are a serious tripping hazard as they are covered in a similar carpet to the rest of the floor, which makes them difficult to distinguish especially as the attention of pedestrians is intentionally distracted by the goods on display. An improvement notice was served on this company for all raised areas to be clearly identified. An extension was granted due to a refurbishment of the store, yet later in the year further inspection still identified tripping hazards within the store.

In early 2003 there was a further accident involving a trip caused by one of these plinths. A prosecution was launched by the local authority Inspector and as a result the group were fined £9000 and ordered to pay the authority's prosecution costs.

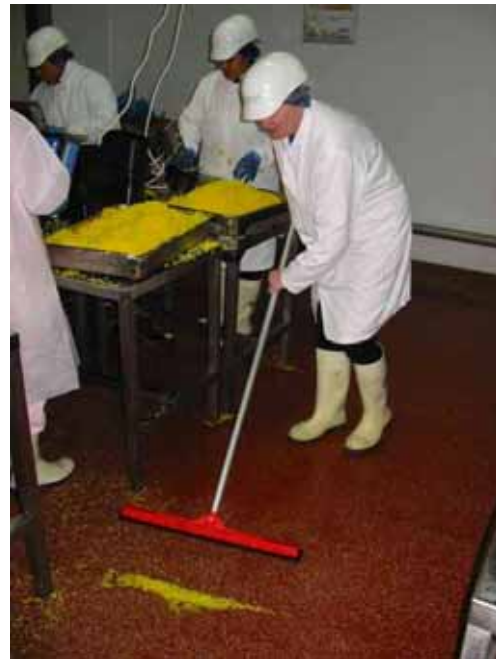
premises, seeing where (& when) they happen most and establishing why. For example, this process helped management to identify that sauce getting onto the floor seemed to be responsible for a number of slipping incidents. (A market driven change in product specification actually did away with their sauce line, so that issue went away on its own.)

**Some food spillage was inevitable.**

Production lines no longer had fixed hose-pipes for swilling down as it was found that they had often been just left running resulting in a lot of water on floor surfaces and wasted money on water bills. Hoses can now be collected from the equipment stores when they are needed for cleaning down but must be returned. Instead, one person on each processing line is designated as being responsible for clearing away any food spillages as they happen. Floor contamination by water and product is now much less – so fewer slips.

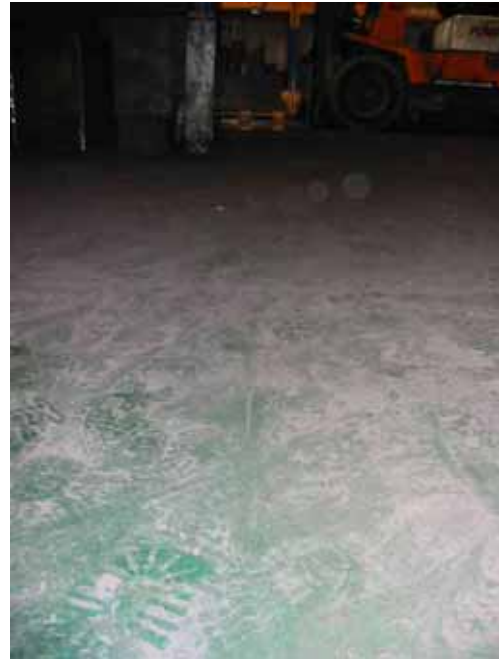
The slip risks resulting from machining dust became a point of discussion when a HSE inspector slipped on the workshop floor during a routine health and safety visit. The inspector was not hurt but the company did agree that processing dust finding its way onto the floor in that area did make it rather slippery. Workers too said that the walkways and working area floors were very slippery, even more vulnerable were visitors to the workshops (such as staff from the offices) as they were often taken unawares by the slippery nature of the floors.

The painted concrete floors of the workshop could not be completely prevented from becoming contaminated with fine dust (up to 10 microns) from the cutting and machining of graphite components. Extract ventilation at machines was effective up to a point but the filtration systems did not seem to be able to capture as much of the dust as was needed, allowing some to be deposited on surfaces. This was compounded by the system of emptying by hand the bags holding the filtered out dust; the manual process resulted in some dust being re-released and contaminating walkways.

The company set about dealing with this in two ways. Improving the floor grip so that it was better able to cope with the conditions and reducing dust contamination finding its on walkways.

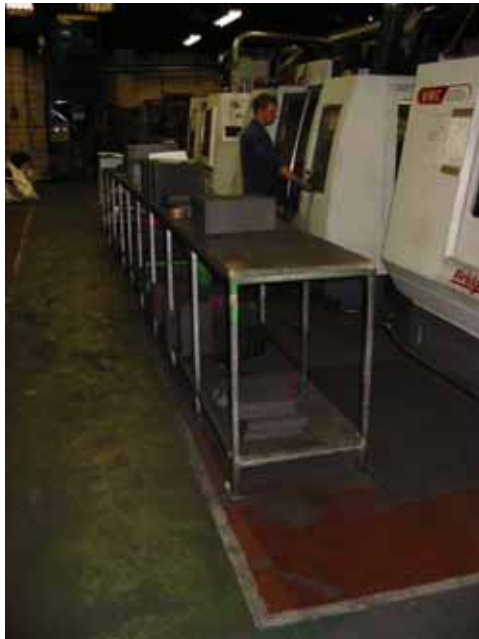
**Treated walkways and work areas.**

Trial treatments were carried out on various parts of the floor using epoxy paints with 'inclusions' of various sorts and particle size to give increased surface roughness and grip. The best seemed to be gritty particles in a two-part epoxy – workers found it gave secure footing whether clean or with dust on it. Tests confirmed that the surface (with about 33 microns of surface roughness) did indeed give very good slip resistance when clean and still performed well when deliberately coated with carbon dust.

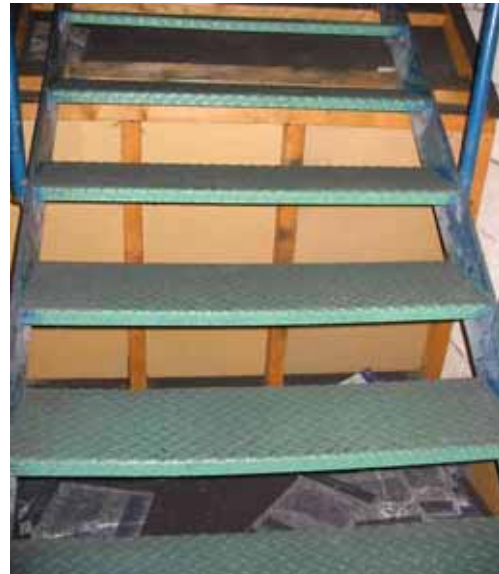
The company even found the treatment worked on profile-surfaced metal stairs that, although only occasionally used, had been said to be especially slippery when dusty.

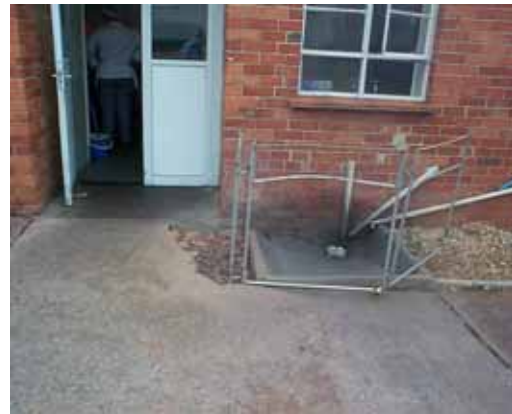
A hole had been dug in a concrete walkway at a hospital in order to repair a leak. The walkway was a busy access route to the hospital kitchen and restaurant. Five months later the hole in the walkway had still not been repaired, nor was it properly protected despite repeated requests to management from staff in the catering department.

When a catering assistant pushing a trolley tripped on the dug up walkway she fell into the shallow hole and sustained injuries that kept her off work for several months. Only after the catering assistant was injured were the necessary repairs carried out to restore the surface of the walkway.

A Health and Safety Executive Inspector investigated the accident. The Inspector concluded that the hole was an obvious and significant hazard and on a busy thoroughfare. The risk was known to the employers (the NHS trust) having been created by them and brought to their attention on a number of occasions before the incident. There was evidence of several 'near miss' or minor injury incidents involving the hole prior to the catering assistant's accident and there were indications that repair work on the walkway was deliberately delayed so that several jobs could be 'batched' together.

**Busy access route to a  
hospital kitchen.**

The Inspector served Improvement Notices on the trust requiring them to carry out risk assessments of all their pedestrian traffic routes and floors – a task that they should already have carried out as a routine good management practice. The Inspector also prosecuted the trust for breaches of the Health and Safety at Work etc Act 1974 and, on hearing the trust plead guilty to the offence, the court imposed a penalty of a fine plus costs totalling more than £7000.

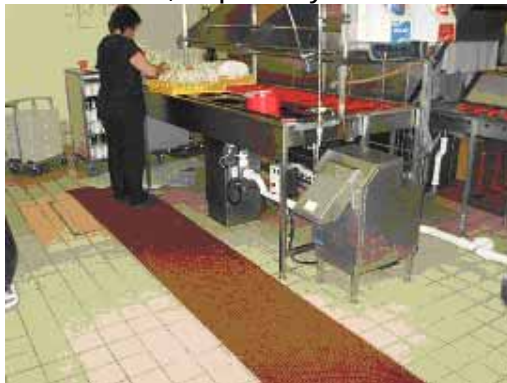
The inspector found that the tiled floor appeared to be in good condition yet it still felt slippery even when the tiles looked to be clean and dry. When just small amounts of water got onto the floor it was found to be very slippery. To make matters worse, some areas of the kitchen floor sloped, increasing the slip risk. Kitchen staff could be seen walking with a very peculiar gait to try to avoid slipping. Floor ‘safety’ mats had been put down in some parts of the kitchen, such as in the dish wash area, but these were slippery to walk on too, especially when wet.

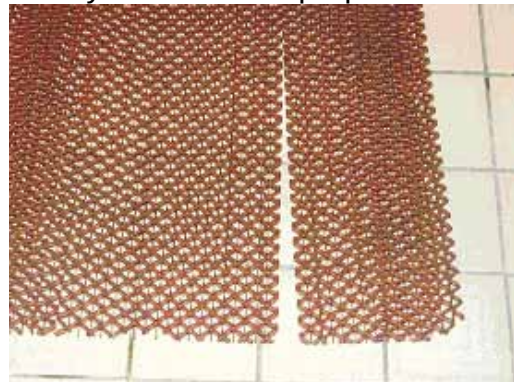
The company's safety records examined by the Inspector showed that there had been other slip incidents in the area but the response had been to provide the most heavily contaminated areas, such as the dish was, with matting – matting that was itself slippery, especially when wet. Scientists from the Health and Safety Laboratory examined the tiled floor surface and the matting and confirmed that the Inspector was right to conclude that risk of slipping was unacceptably high because of the lack of slip resistance of the tiles and the matting. The floor surface was clearly not fit for the purpose

company, but concluded to be inadequate or inappropriate, they eventually replaced the floor surface with one that was suitable for use in an area where the total elimination of floor contaminants would never be possible. The new floor was specified to provide enough grip, even in wet or contaminated conditions.

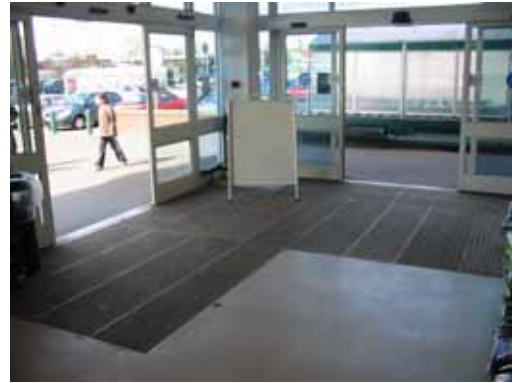
**'Old style' store entrance.**

The floors in the store had been in place for several years and were quite smooth, even light contamination of the floor by water or spillages could cause people to slip and fall. The fixed matting at the store entrance was quite limited and of a type intended to remove grit and dirt from shoes rather than to dry them.

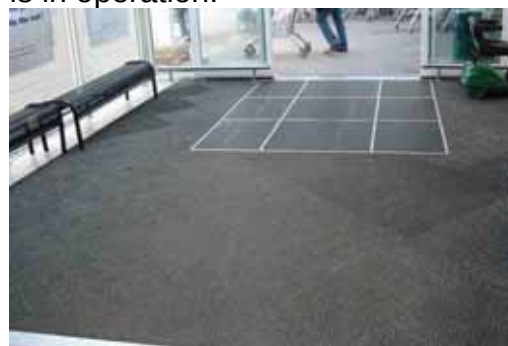
**A store entrance following improvement work.**

The interim changes to the store entrance were not seen as a long-term solution but were adopted as sensible responses pending the more permanent floor surface and store entrance systems being introduced as part of the rolling store refurbishment programme. The spill station system – providing the right awareness, right training and right equipment – is being introduced into more and more stores and the company is already able to demonstrate a 25% fall in slipping incidents where the system is in operation.

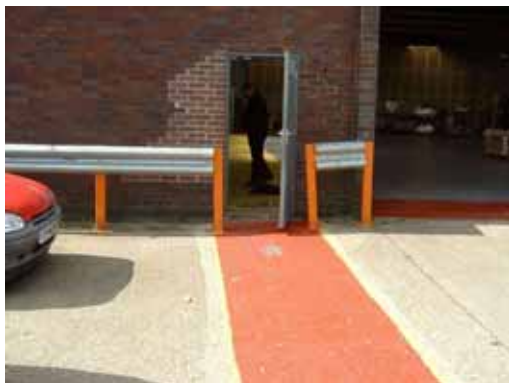
An employee arrived for work and, on finding the normal staff entrance obstructed by a pool of water and carelessly discarded cleaning equipment, had to go in through the adjacent vehicle entrance. She had no way of knowing that the paint on the floor was still wet and, quite unsurprisingly, slipped on it and fell heavily. Not only did she get covered in the wet paint but the fall broke her wrist too.

**Pedestrian access route and painted vehicle access route floor.**

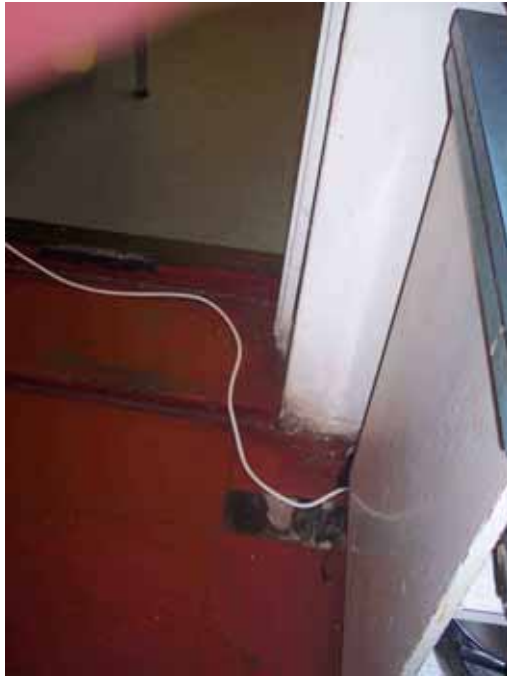
An electrical cable was seen trailing across a step. A storeroom, which had to be regularly accessed by staff to obtain items such as toilet paper and the highchair provided for customer use, was almost completely obstructed and virtually inaccessible because of the clutter of things being haphazardly stored there.

The problems in the storeroom were sorted out and the trailing cable was re-routed after the visit. The local authority's decision to take the prosecution was influenced by the impact that it would have on other duty holders through raising awareness of simple tripping hazards such as electrical cables and the importance of avoiding them.

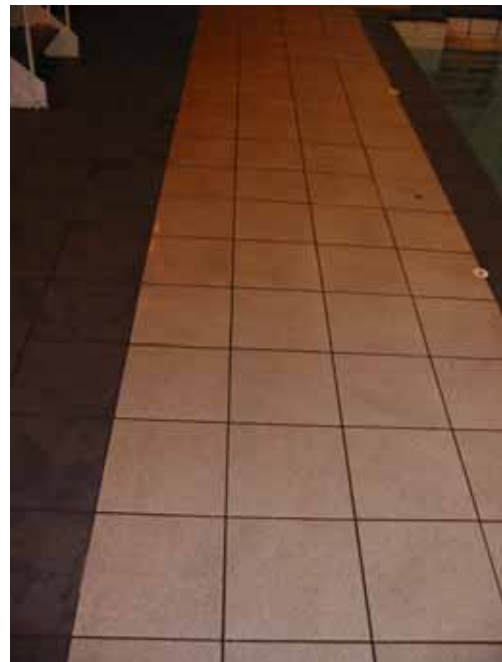
The tiled floors were rather smooth and offered little grip, especially for pool users going barefoot or the staff wearing training shoes. They were also rather old and, having had a lot of foot traffic for many years, rather worn. The clear conclusion was that something had to be done about the floors throughout these areas of the site.

surfaces to provide more grip. The manager decided against this on the grounds that upkeep of an etch-treated floor requires regular re-treatment of the tiles to maintain enhanced grip and that involves the use of chemicals for which special training and handling would be needed. He felt that he would rather avoid that if he could. He also did a costing exercise and found that the costs of the initial acid etch treatment, periodic re-treatment and the equipment needed did not seem to offer any financial savings when compared to replacing the old and worn tiles with something more suitable, especially as it proved possible to lay new and better tiles straight onto the top of the old ones. This offered a big saving on removal and preparation costs.
